**rep.LA.nt:** RESEARCH, EDUCATION  
& CONSERVATION CENTER

by BÜNYAMİN SÖNMEZ

RESEARCH, EDUCATION &  
CONSERVATION CENTER

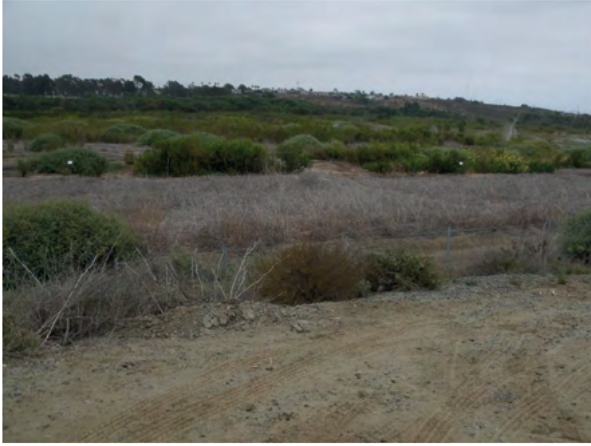
Photo depicts an area of Disturbed Quailbush Scrub toward the center of the Project site. Photo facing east.

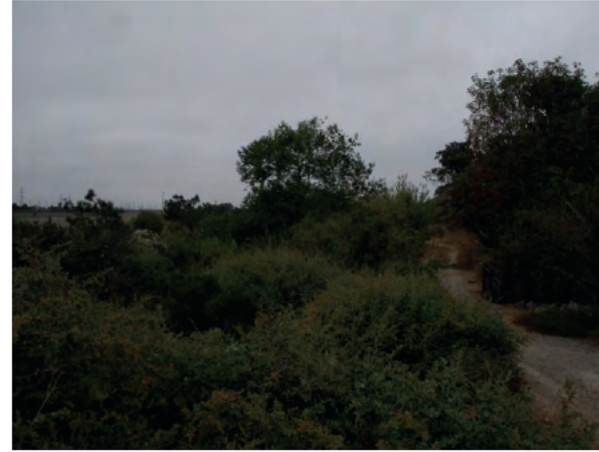
Photo depicts Quailbush Scrub off of Victoria Street on the east side of the Santa Ana River channel. Photo facing north.

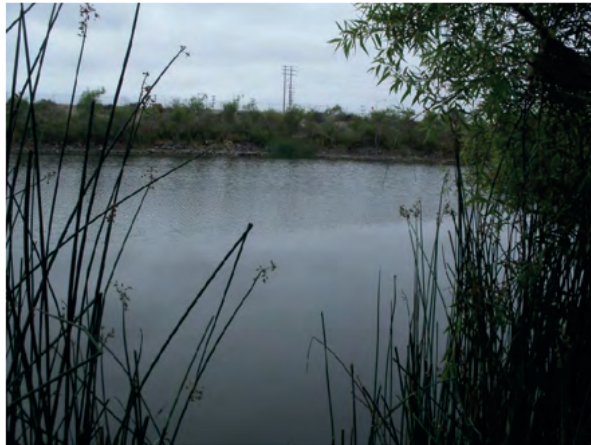
Photo show the large pond from the eastern edge. Photo facing west.

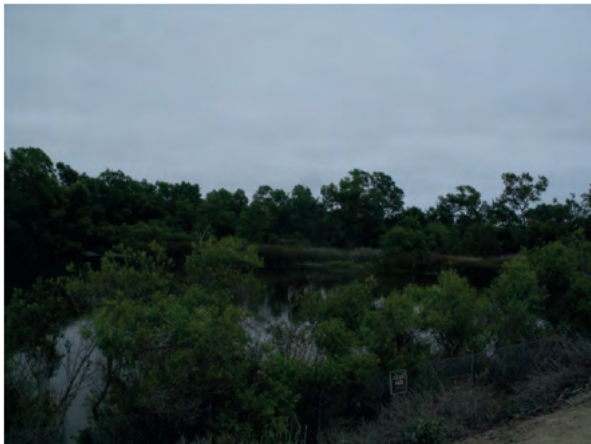
Photo shows Victoria Pond located toward the center of the Project site.

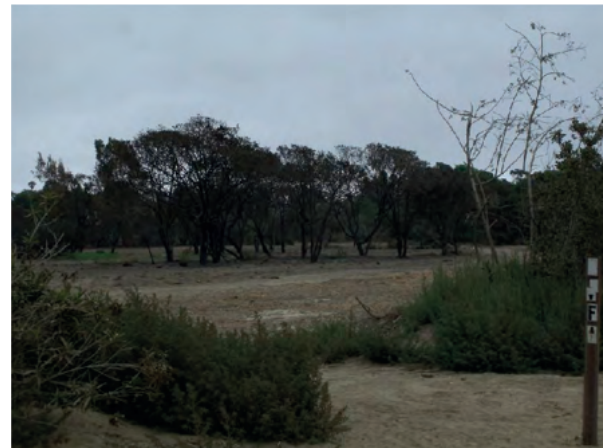
Photo depicts some burned vegetation on the Project site. Photo facing south.

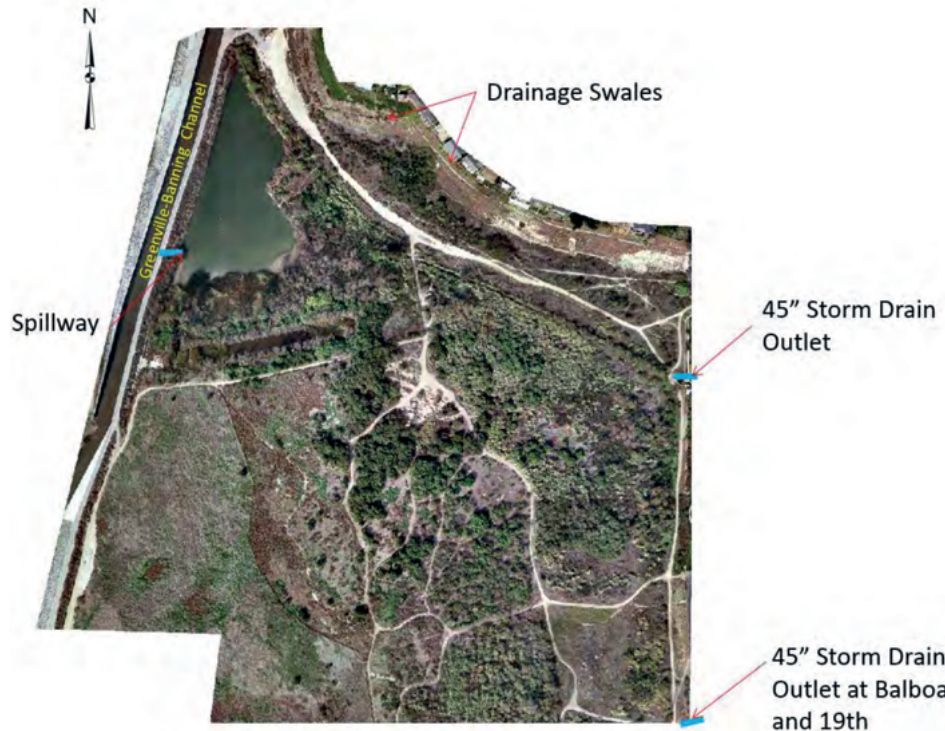
Figure 11: Site Drainage at South Talbert

A variety of water sources (groundwater, tidal, surface ponding and others) exist at South Talbert. This means a variety of wetland habitats (freshwater, brackish, and saltwater) could potentially be supported in the Park. The water table is seasonably high at South Talbert and a shallow, ser

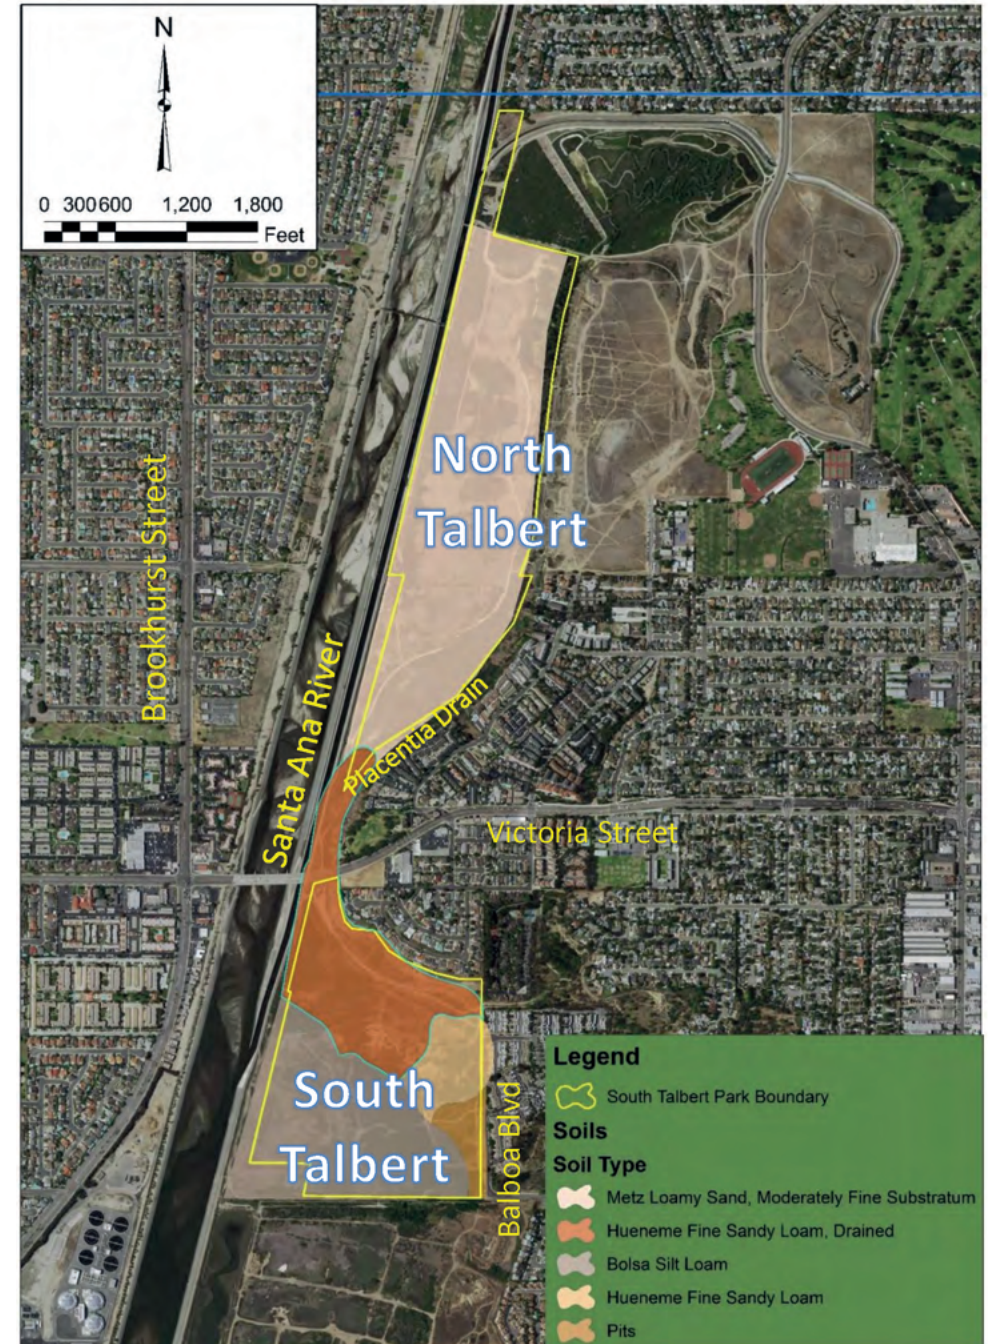
Figure 13: Soil Types Found at Talbert Regional Park (Source: EDAW 1989 & 1991)

For a map of the soils at Talbert Regional Park, see Figure 13. North Talbert is predominantly comprised of Metz loamy sand, moderately fine substratum. The soils at South Talbert consist of a mix of Hueneme fine sandy loam (drained) on the north, Hueneme fine sandy loam on the east, Bolsa silt loam on the south, and a relatively small area of excavated “Pits” on the southeast corner.

The USGS classifies the Park area as an alluvial basin. An alluvial basin contains unconsolidated materials consisting of clay, silt, sand, gravel, and boulders that erode from the mountain slopes and watershed. The soils at Talbert Regional Park were “formed under hydric or seasonally hydric conditions” (EDAW et al. 1989).

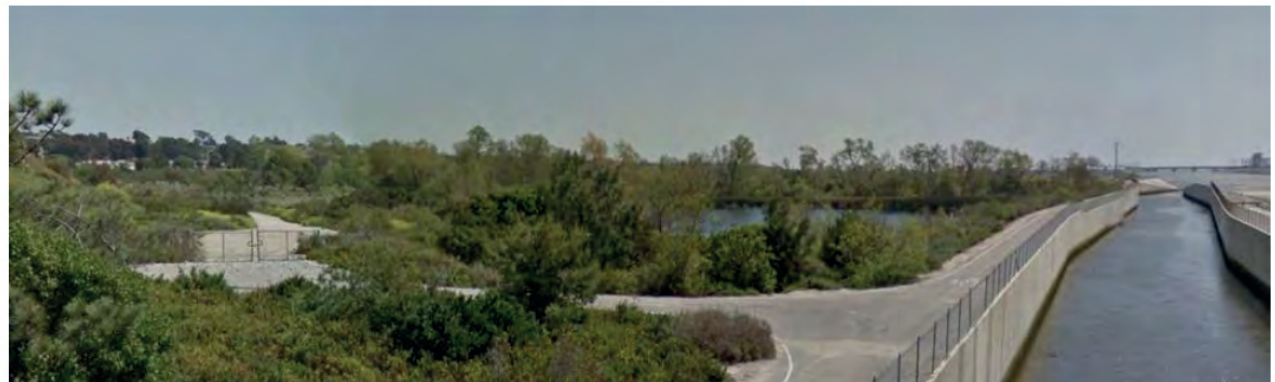
Figure 17: View of Victoria Pond from Victoria Street  
(Source: Google Street View)

A paved multi-use trail is located atop the Santa Ana River flood control levee and is frequently used by pedestrians, joggers, and bicyclists. This trail provides access to both North Talbert and South Talbert and is available to the public from the flood control levee along the GreenvilleBanning Channel. Victoria Pond is visible from Victoria Avenue and the channel levee (see Figure 17). The pond is a scenic natural resource and supports fish, however access to the pond is restricted by a fence along its perimeter. Despite the fence, unauthorized fishing has been observed at Victoria Pond.

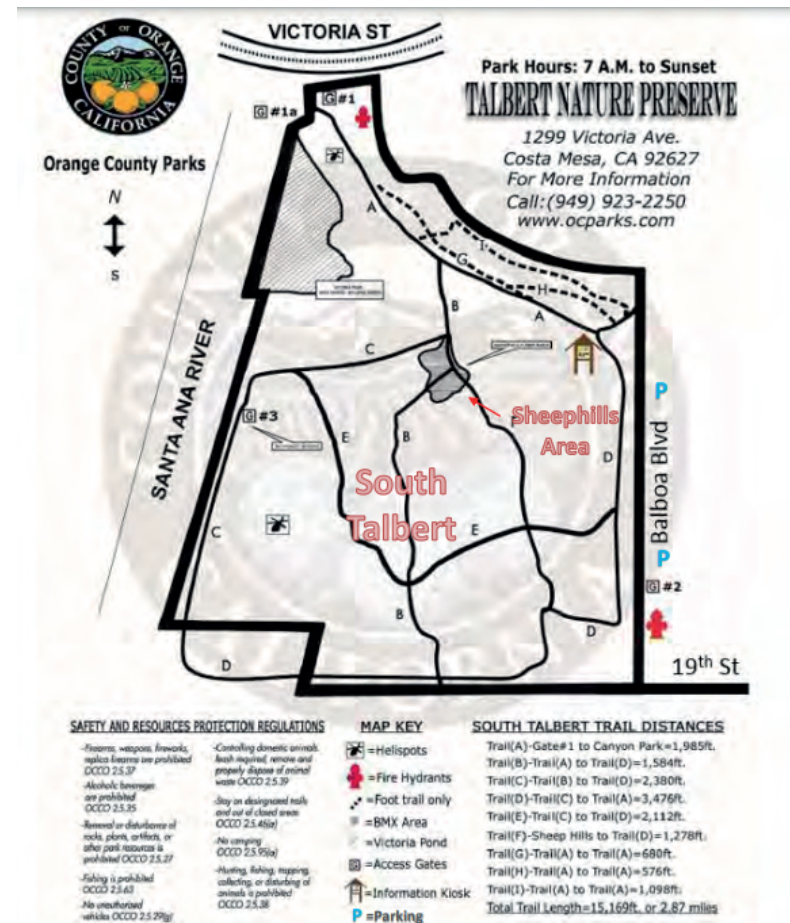
Figure 15: Trails at South Talbert  
(Source: OC Parks Website)

Both North Talbert and South Talbert have extensive trail networks, which are accessible to the public by foot and bike.

A mixture of decomposed granite trails that transition to dirt trails and asphalt trails near the flood control levee make up the trails at Talbert North while the trails at South Talbert are predominantly earthen trails.

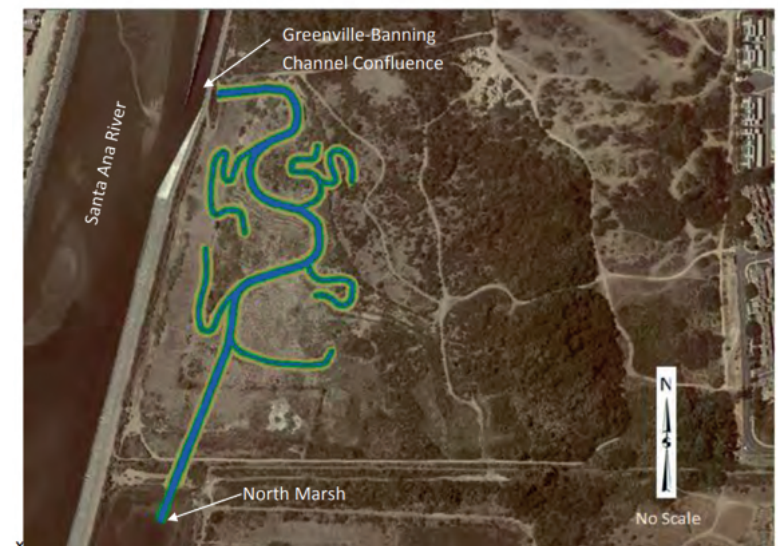
Placentia Drain at North Talbert can intercept urban runoff from the adjacent mesa and presents an opportunity for a bioswale or improved freshwater riparian habitat.

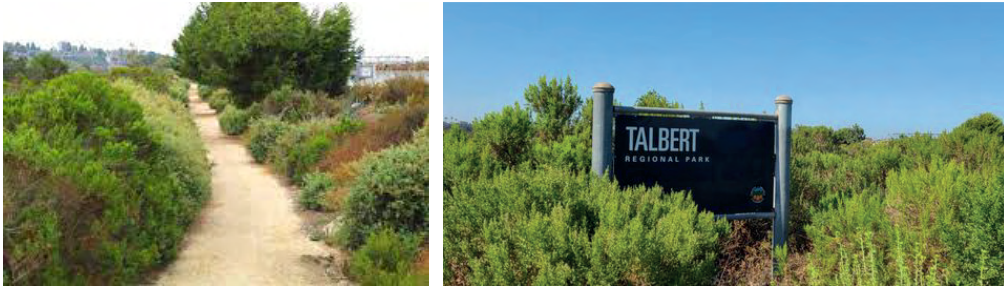
South Talbert presents an opportunity to design for a variety of habitats (salt marsh, emergent marsh, alkali meadows, freshwater riparian, grasslands, vernal pools). The high water table at South Talbert presents an opportunity to design additional freshwater habitat, i.e., emergent marsh or freshwater riparian habitat.

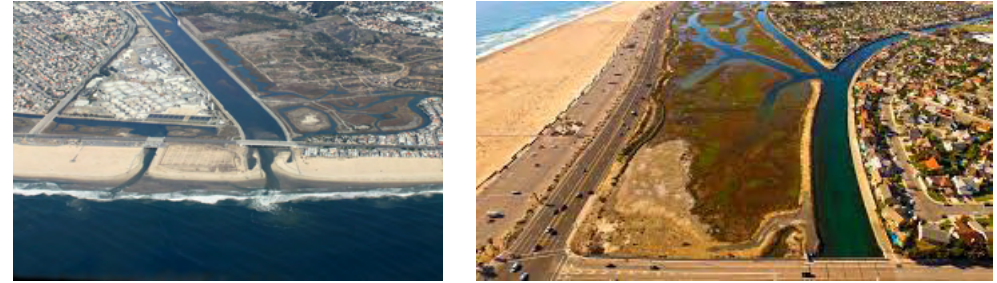
Alternatively, a new hydrologic connection to either the Greenville-Banning Channel or the Santa Ana River could be constructed to convey water from the river to South Talbert, which presents an opportunity for wetland restoration, i.e., salt marsh or brackish marsh.

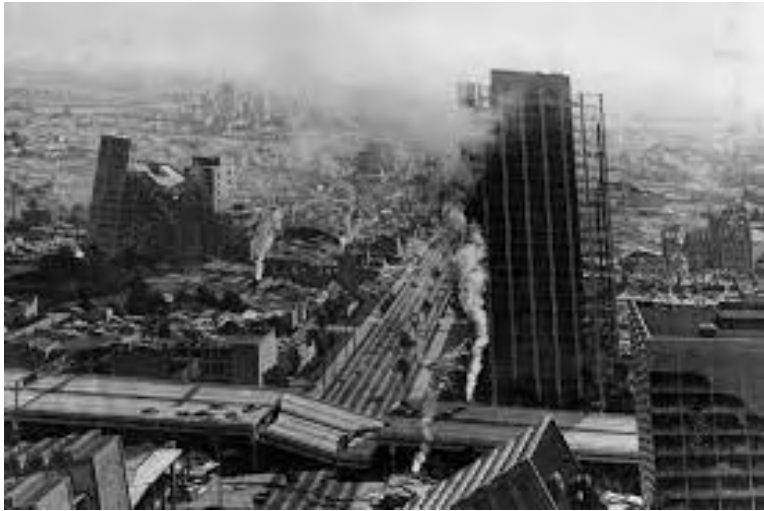
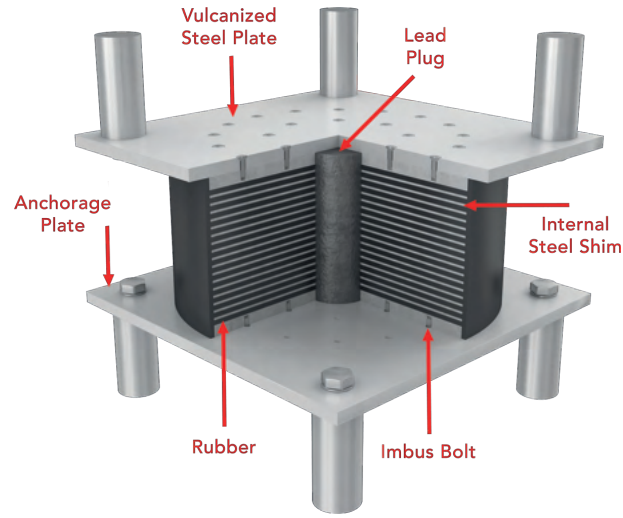
Seismic Isolation Device

Seismic isolation (earthquake isolation or base isolation) is a method that protects the structure and all the components inside the building from the destructive effects of the earthquake by creating a layer between the building and the ground thanks to special devices (earthquake isolation devices) placed between the building itself and its foundation.

Although the building is a long building horizontally in case of earthquake, it will act as two parts thanks to the designed foundation system. It aims to minimize damage thanks to its seismic isolation tool and structural solution.

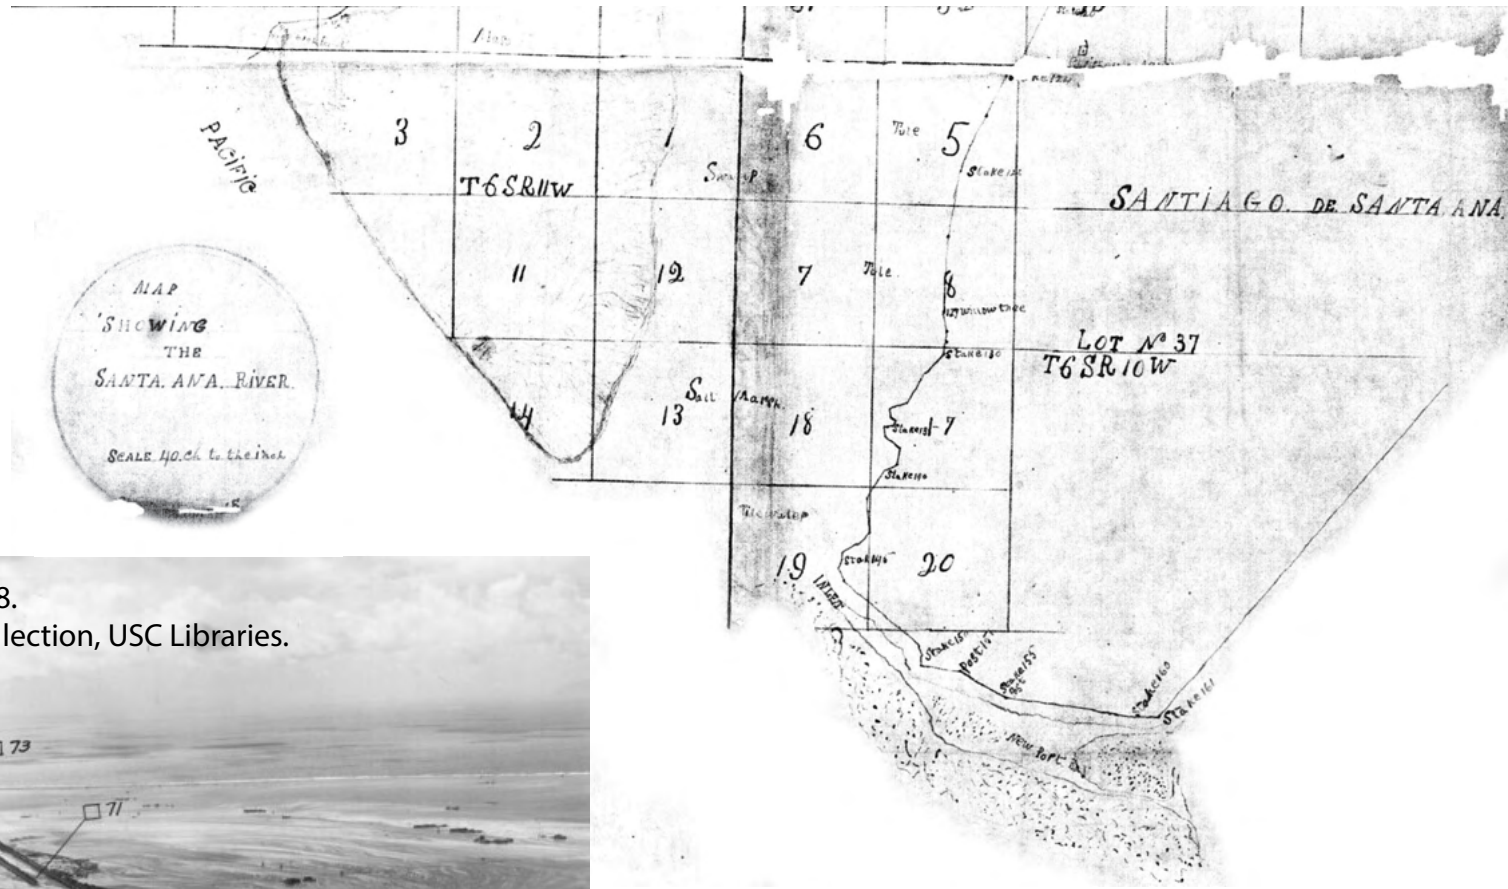
Aerial view of a flooded Santa Ana River in 1938. Courtesy of the California Historical Society Collection, USC Libraries.

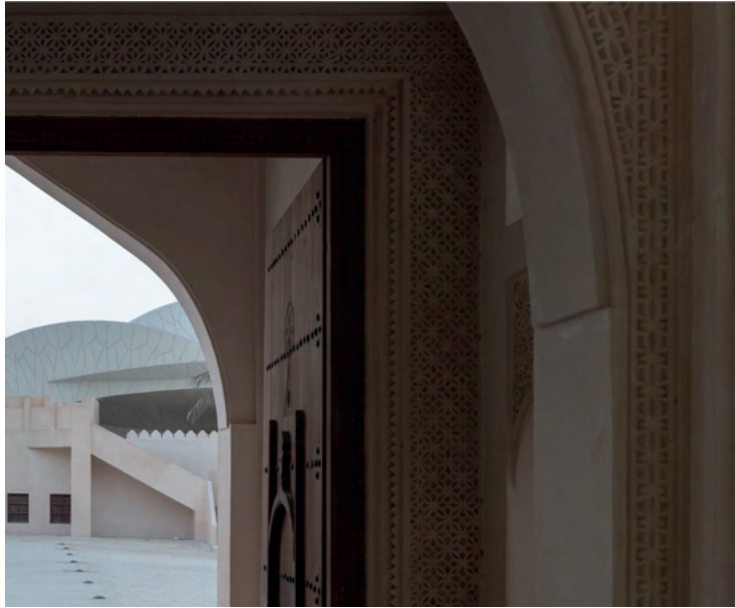
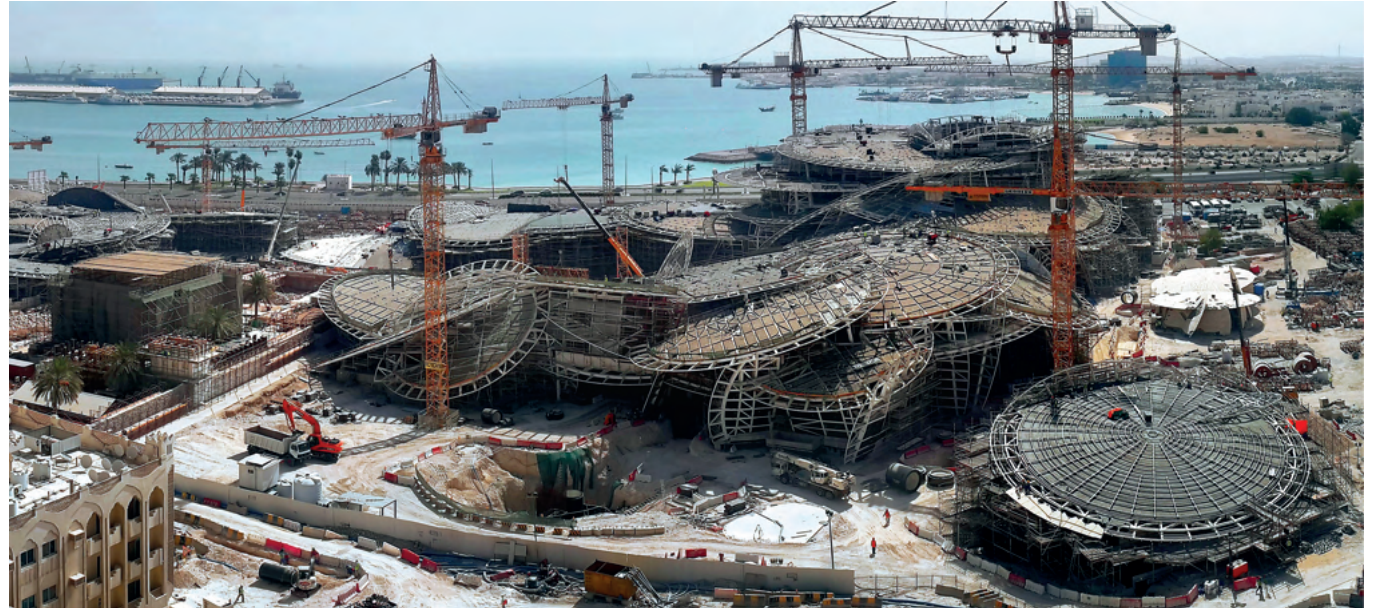
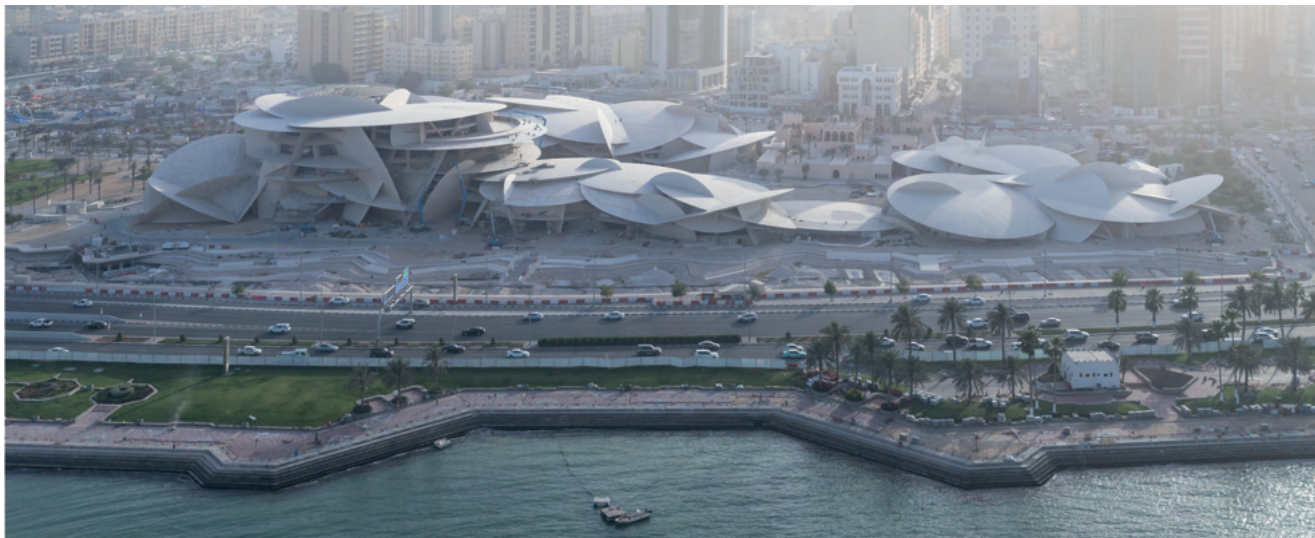
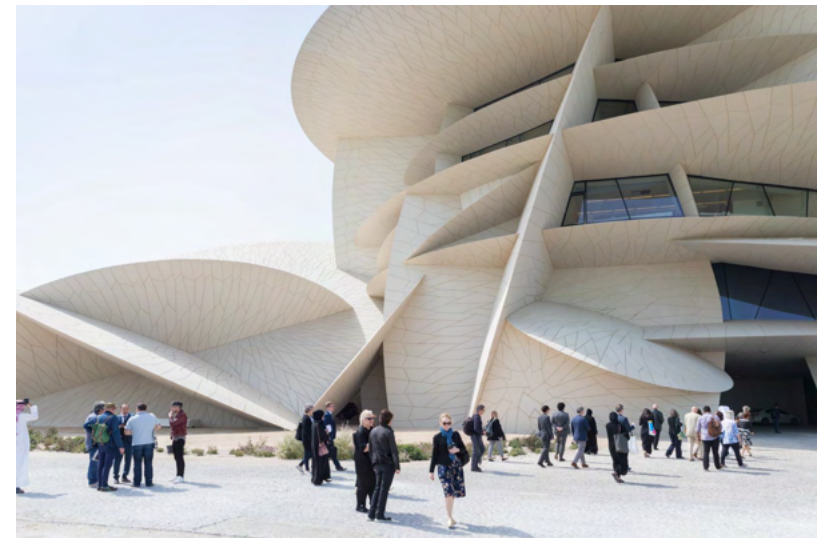
# National Museum of Qatar / Atelier Jean Nouvel

The building is composed of large interlocking disks, spherical in section, and of different diameters and varying curvatures. Some disks are 'horizontal' and rest on other disks. The 'vertical' disks constitute the building's support and transfer the loads of the horizontal planes to the base. Like the exterior, the interior is a landscape of interlocking disks.

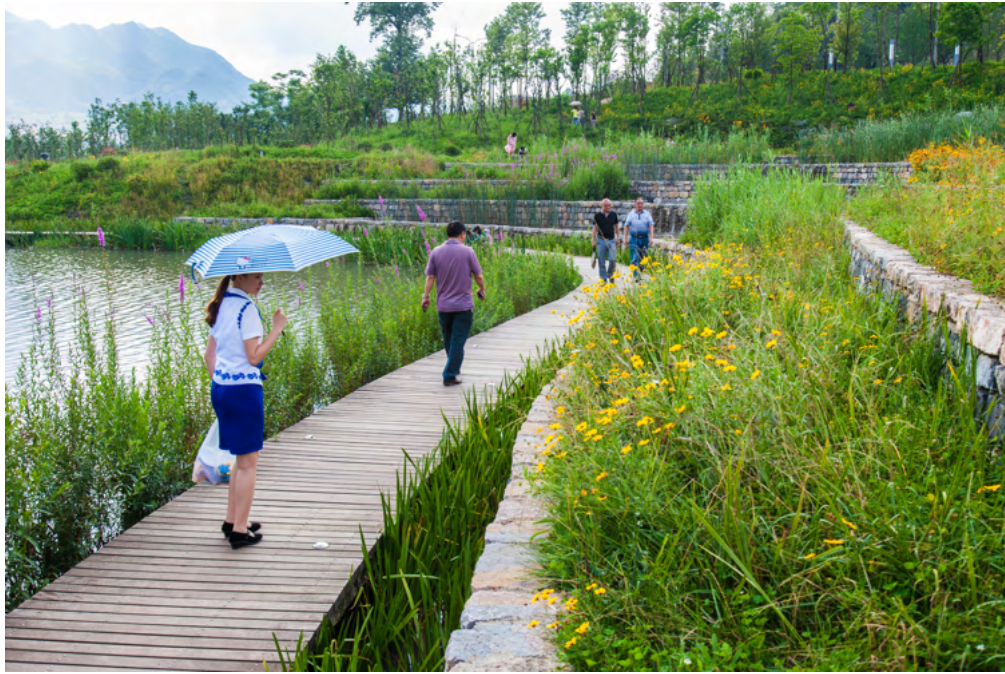
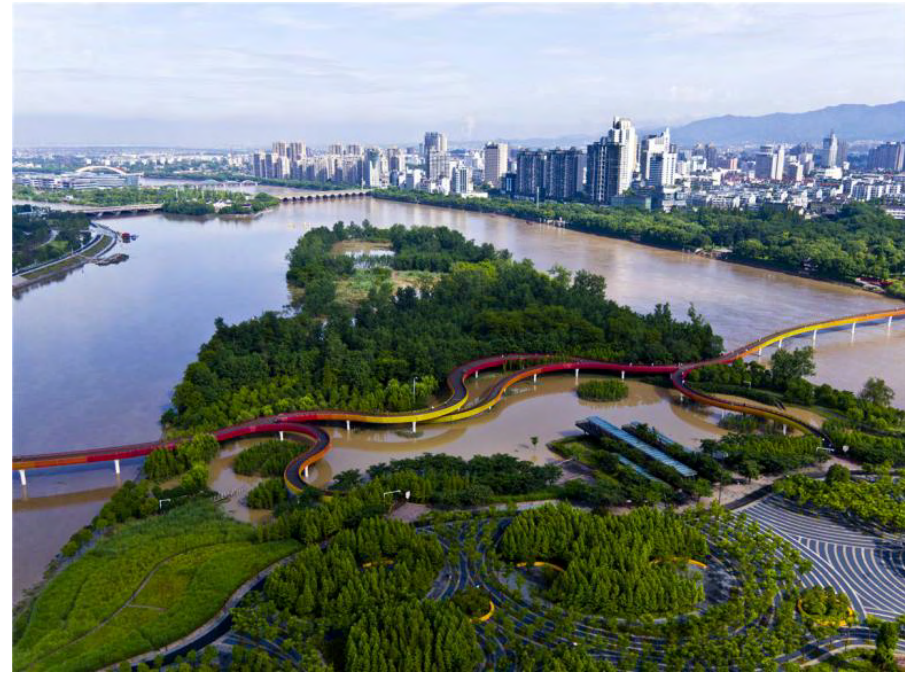
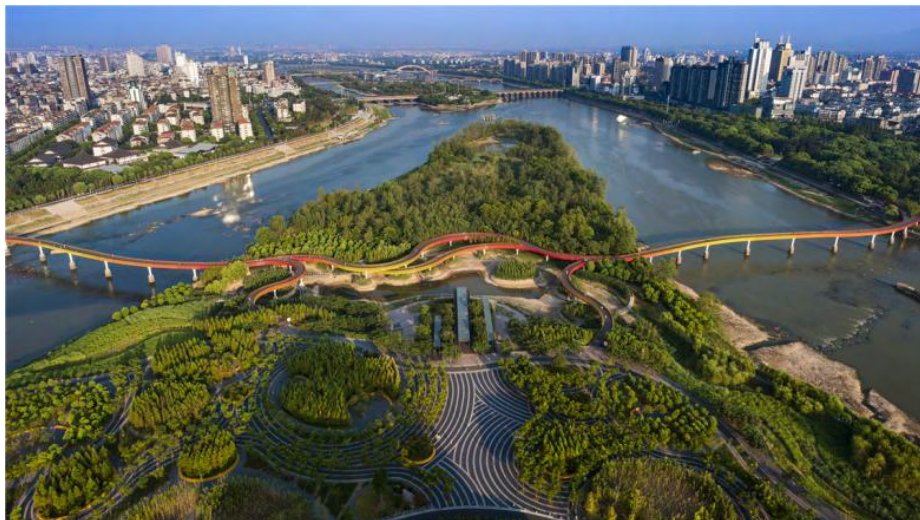
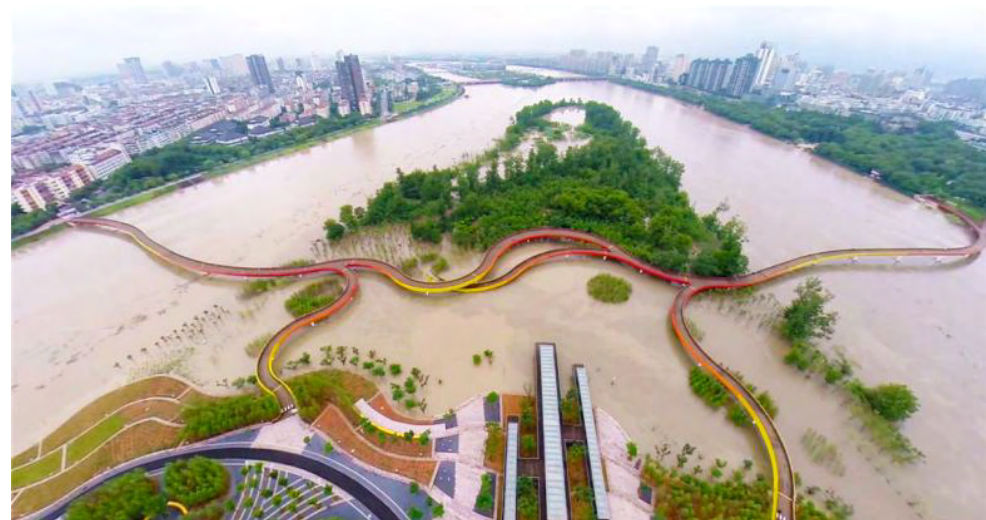
# Minghu Wetland Park, Turenscape

Through a series of regenerative design techniques, particularly measures to slow down the flow of storm-water, a channelized concrete river and a deteriorated peri-urban site have been transformed into a nationally celebrated wet-

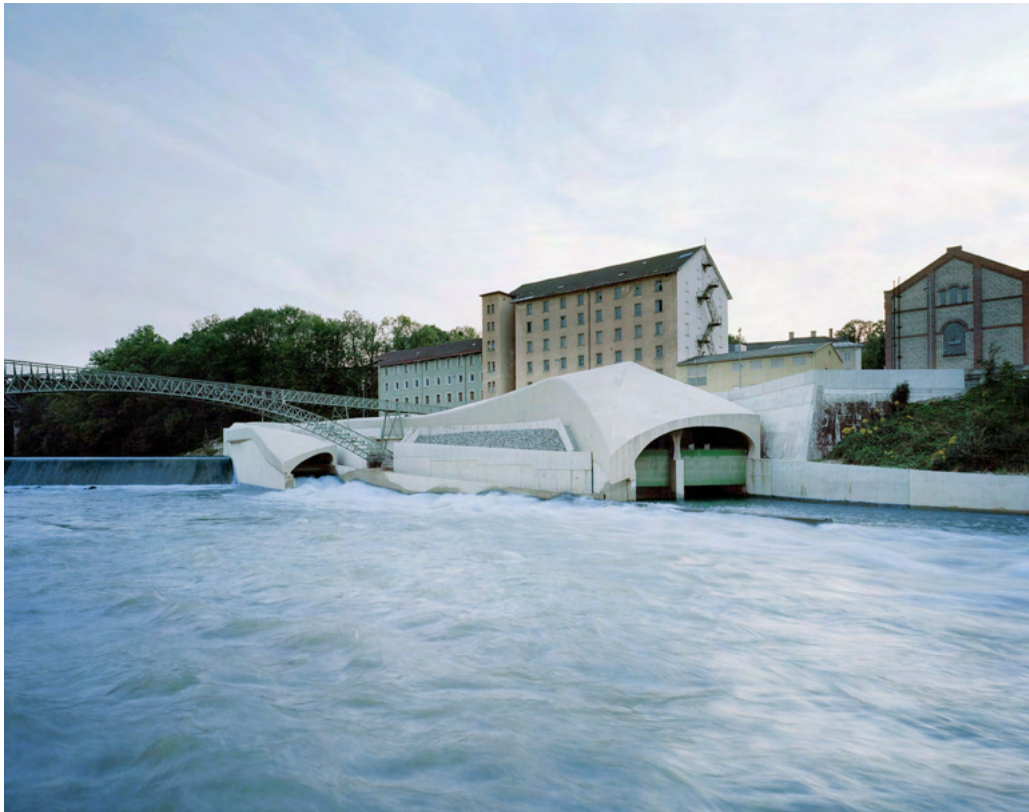
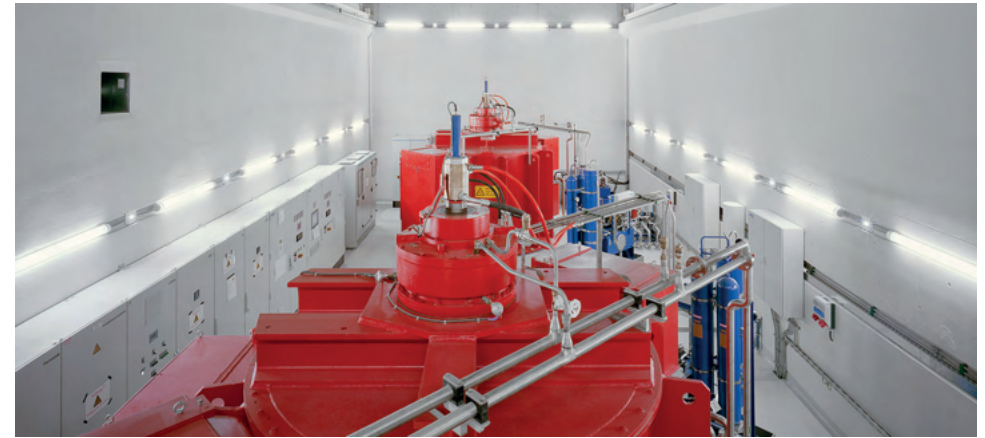
# Hydro-electric Powerstation / becker architekten

The starting point of the design considerations was the symbolic representation of the water dynamics, which change from a calm state at the water inlet to the churning and pitching of the water near to the turbines, before subsequently returning to a calm state after the electricity generation.

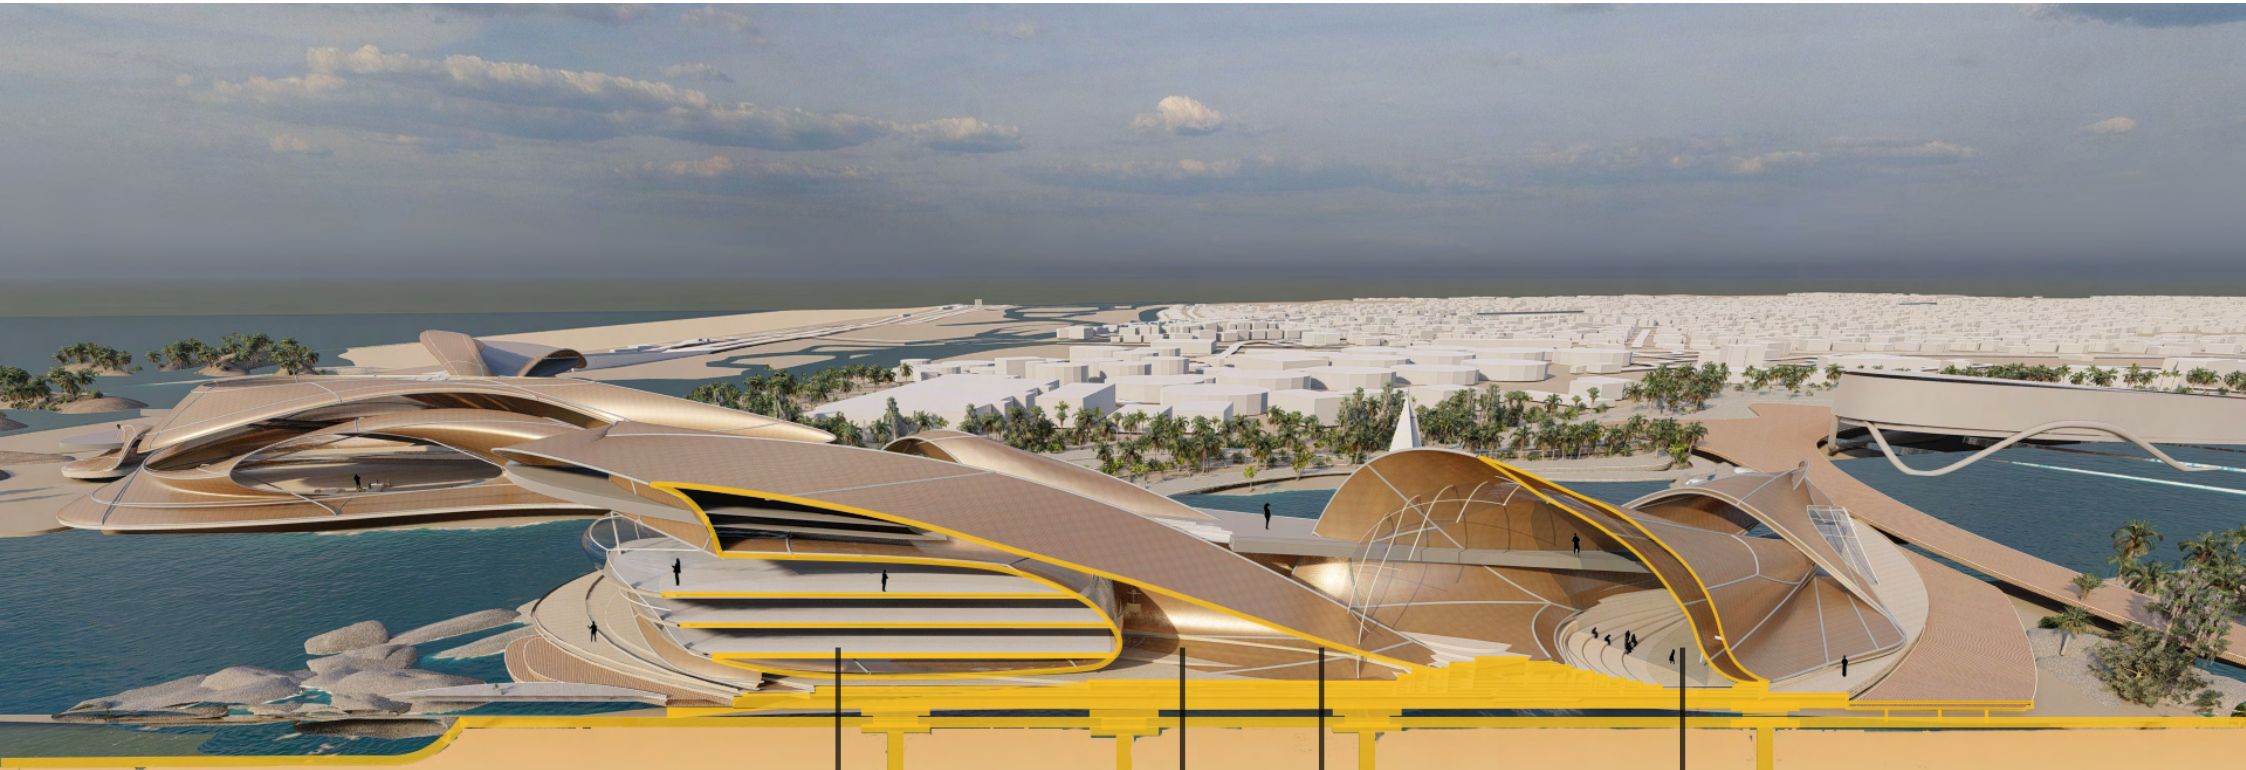
# FUNCTIONAL DIAGRAM

Laboratories

Vertical Core

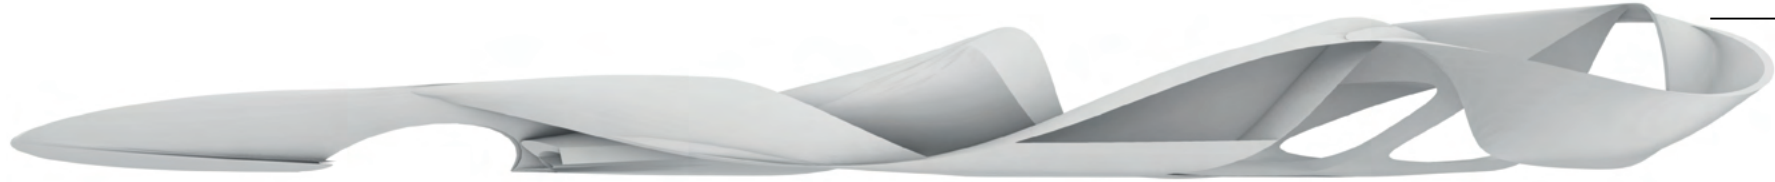
Digitally Fabricated Titanium Panels

Insulation

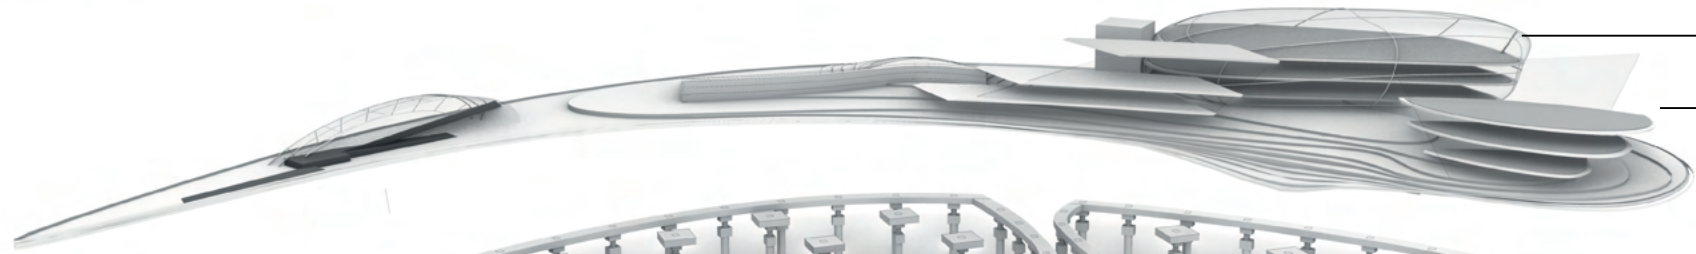
Steel Skeleton Structure

Steel Roof

Acrylic Glass

I Section Beam Floor

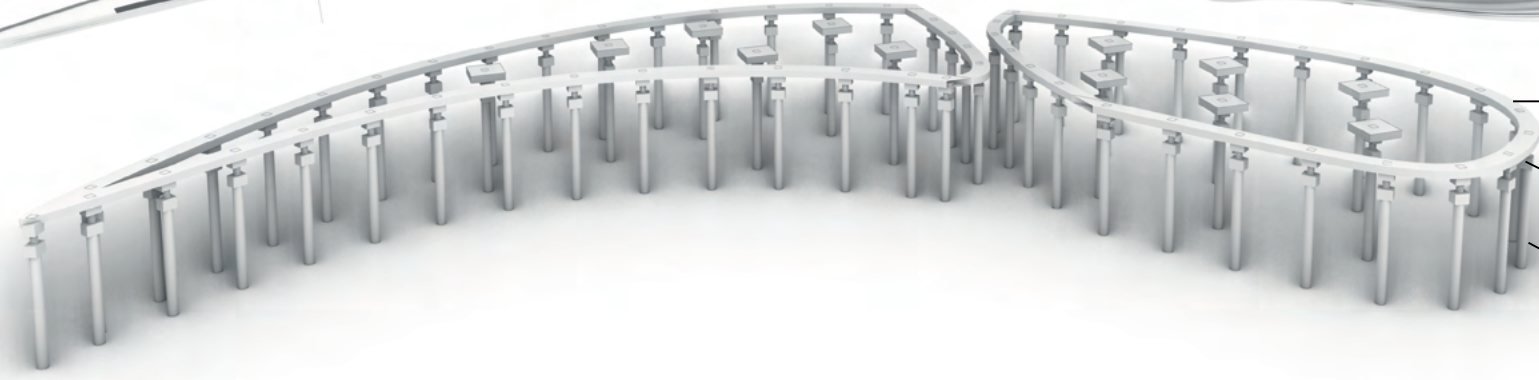
Continuous Foundation

Seismic Isolation Device

Pile Foundation
